Intel[®] 82801DBM I/O Controller Hub 4 Mobile (ICH4-M)

Specification Update

September 2006

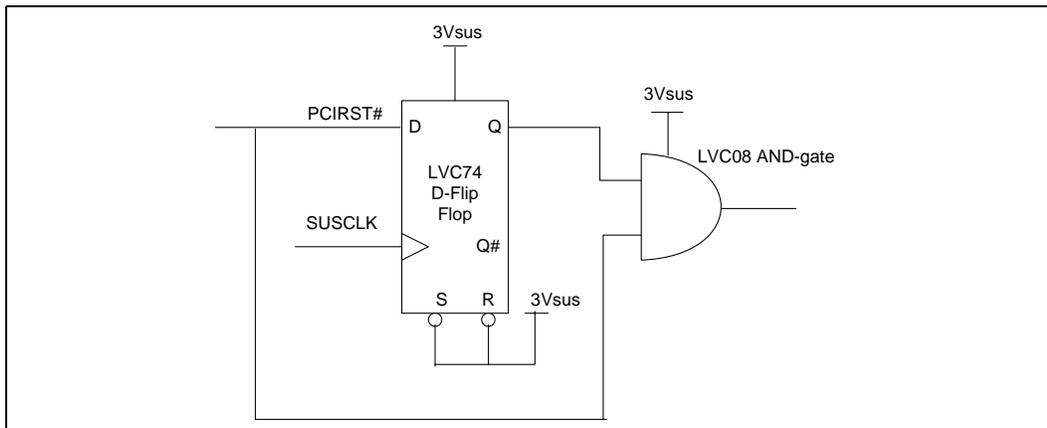
Problem: The ICH4-M specified 1–3 RTC timing of SUS_STAT# inactive to PCIRST# inactive violates the LPC Rev 1.0 specification of “at least 60 μs.”

Implication: Some LPC devices (based on LPC Rev 1.0) may not properly reset resulting in failure of the system to boot or resume from a sleep state.

Workaround:Use any one of these three workarounds:

1. Delay PCIRST# by 1 SUSCLK using a D-flop and an AND gate to the LPC devices.
