Intel® Atom™ Processor N400 Series

Specification Update

September 2010

Revision 006

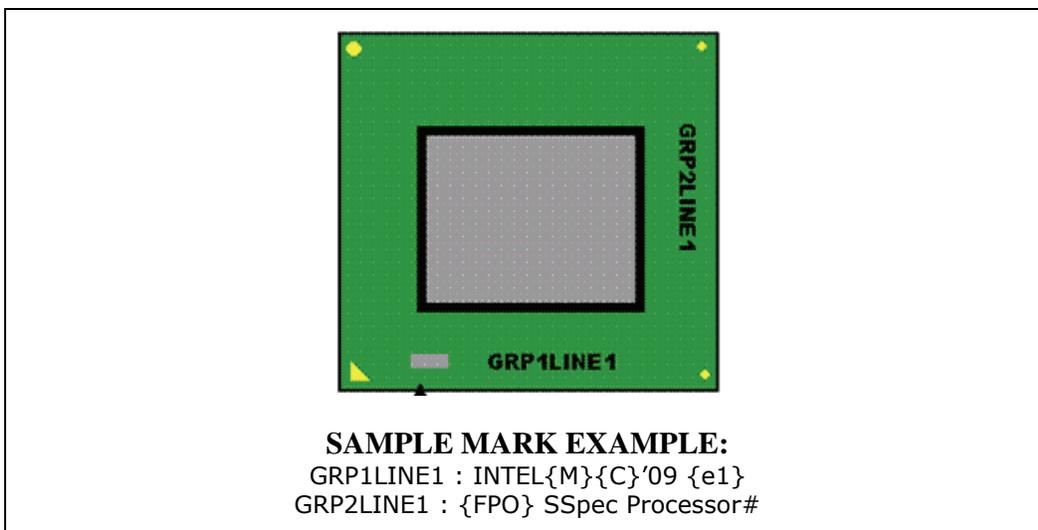
Figure 1. Intel Atom Processor N400 Series (Micro-FCBGA8) Markings

Intel Atom Processor N400 series is identified by the following component markings.
